CAPITALinfrared

Confidential Inspection Report

123 Sample St, Washington, DC 20011

Date: 1/16/2014	Time: 02:00 PM	Report ID: Sample ITI Moisture
Property: 123 Sample St Washington DC 20011	Customer: Kevin Richardson	Real Estate Professional: Not Applicable

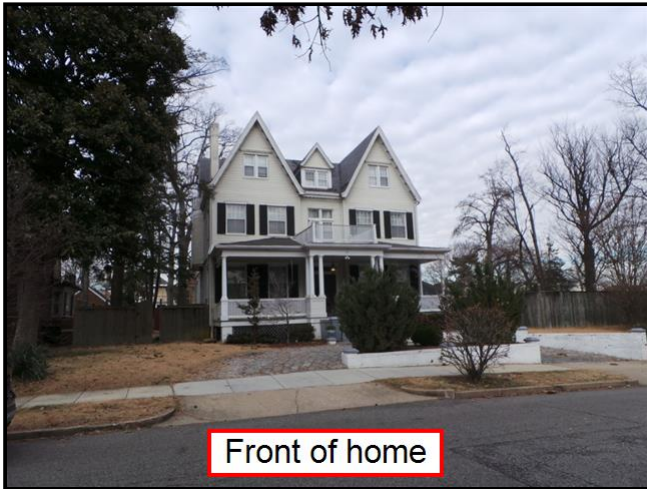
1.1 Item 1(Picture)

Front of home

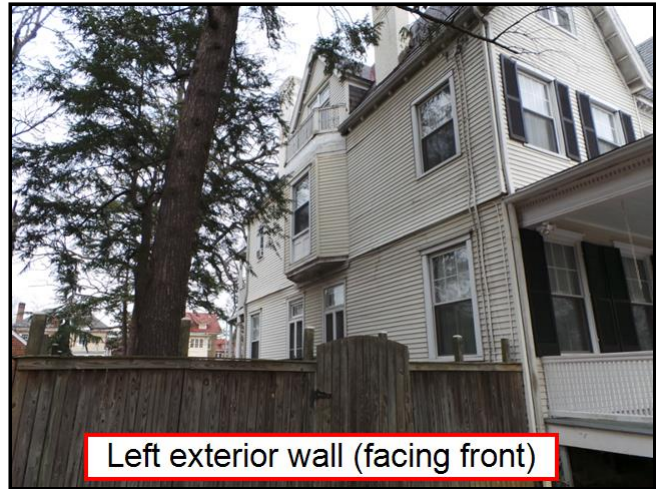
1.1 Item 2(Picture)

Left exterior wall (facing front)

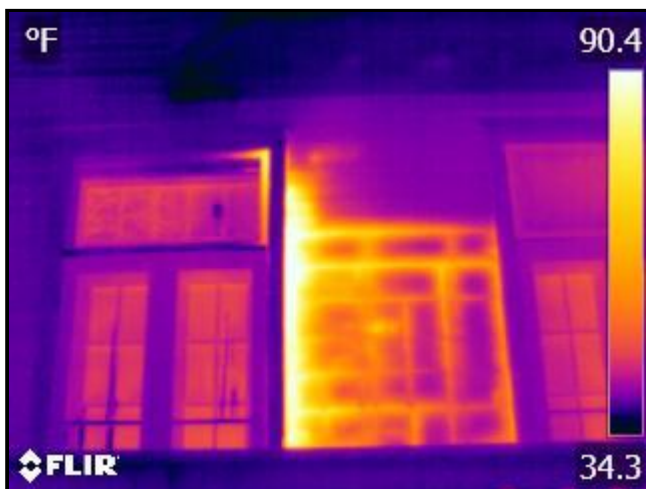
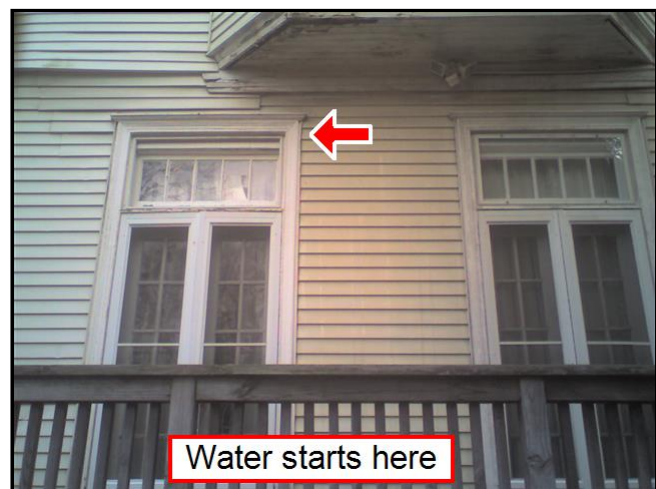
(1) A section of the exterior wall at the left side of home (facing front) displays **atypical** thermal anomalies. These type of thermal patterns are consistent with latent moisture. The thermal images below depict warm water flowing on the exterior house wall. There are hot and cold vertical riser pipes inside the wall cavity. I suspect there is a leak on the hot riser pipe, which is causing water to leak inside the wall cavity and on the exterior house wall.

(2) **Exterior Exception #1:** Warm water penetrating the exterior wall on the left side of home beneath the bay window. The water is suspected to be from a pipe leak (hot water pipe) near the upper right corner of the window/door adjacent to the dining room.

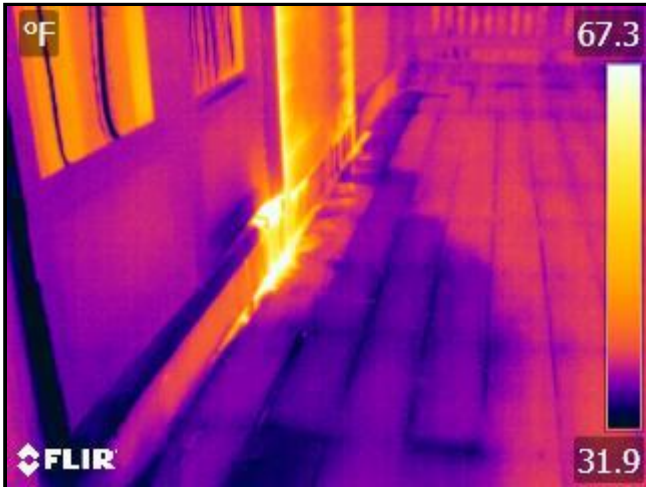
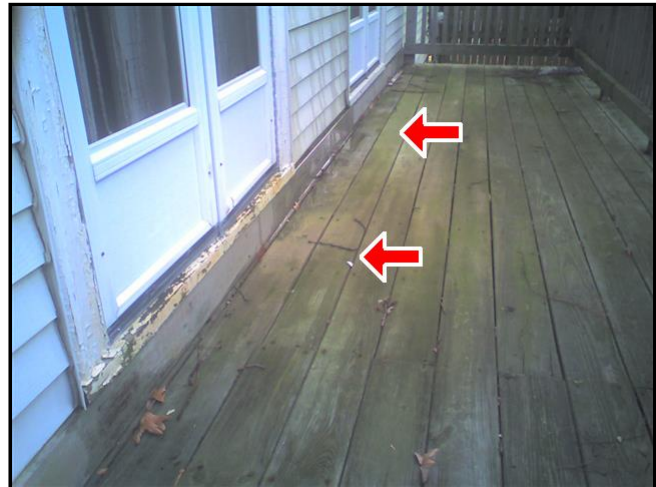
(3) **Exterior Exception #2:** Warm water penetrating the exterior wall on the left side of home beneath the bay window. The warm water is flowing down the exterior house wall and hitting the window/door

threshold and the floor of the wood deck. The exterior water flowing down the house wall, along with the water leaking inside the wall cavity, has caused moisture intrusion in the basement.

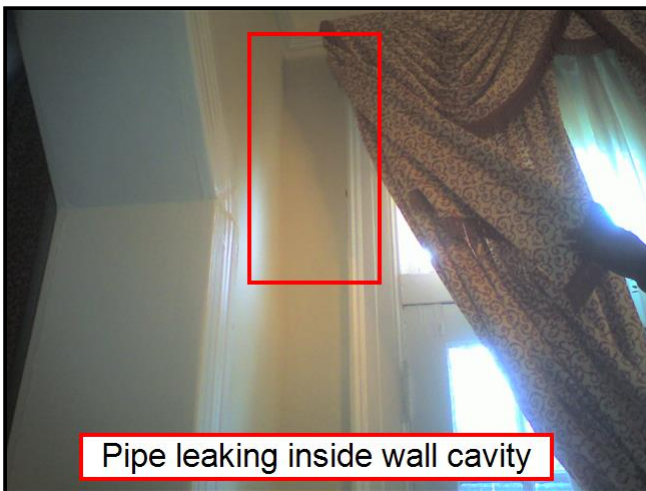
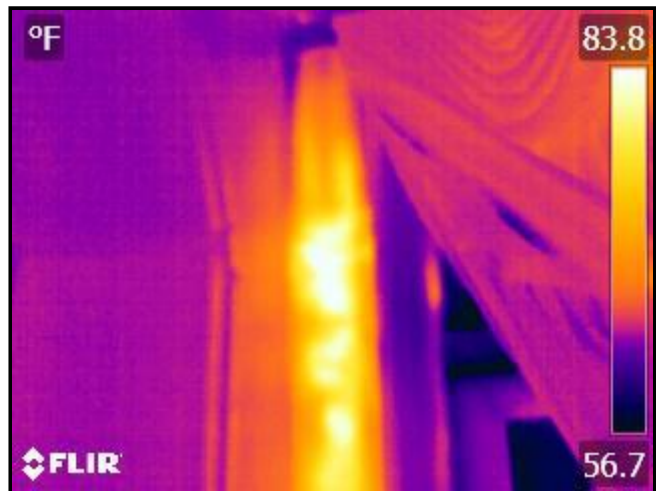
(1) A section of the interior wall and floor at the dining room (left wall - facing front) displays **atypical** thermal anomalies. These type of thermal patterns are consistent with latent moisture. The thermal images below depict warm water flowing inside the wall. There are hot and cold vertical riser pipes inside the wall cavity. I suspect there is a leak on the hot riser pipe, which is causing water to leak inside the wall cavity, on the floor of the dining room, and down into the finished basement.

(2) **Interior Exception #1:** Warm water leaking inside the wall cavity (left wall) on the left side of the tall window/door adjacent to the dining room. The water is suspected to be from a pipe leak (hot water pipe) inside the wall cavity.

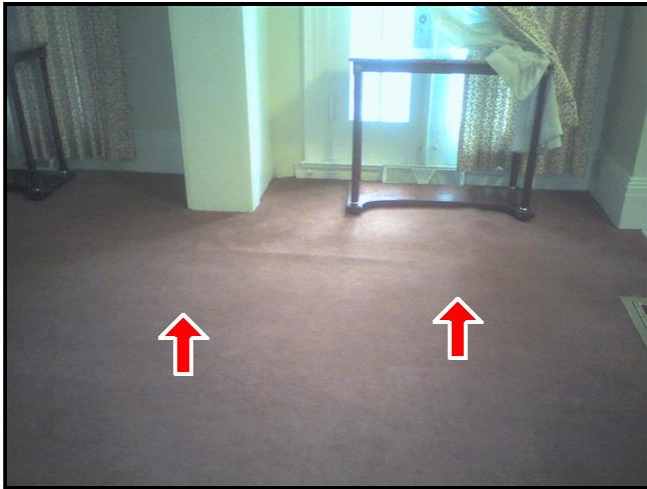
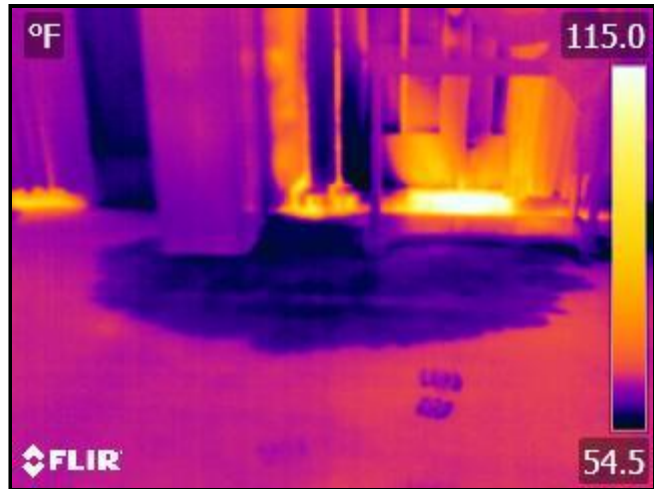
(3) **Interior Exception #2:** Warm water leaking inside the wall cavity (left wall) on the left side of the tall window/door adjacent to the dining room. The warm water is flowing inside the wall cavity and causing moisture intrusion on the floor. The water flowing inside the wall, along with the water leaking on the exterior wall, has caused moisture intrusion in the basement.

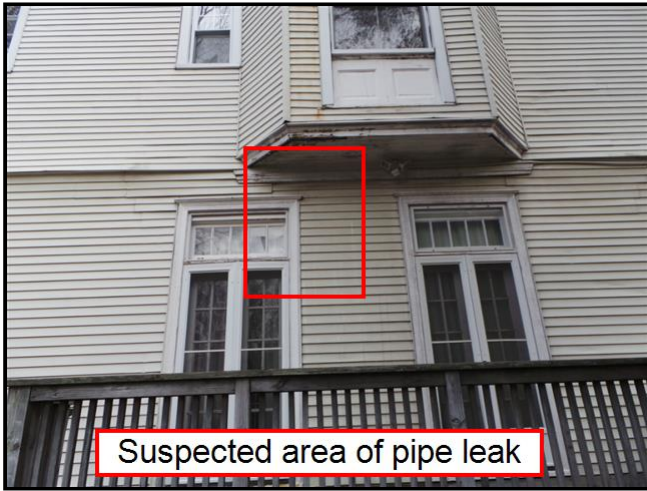
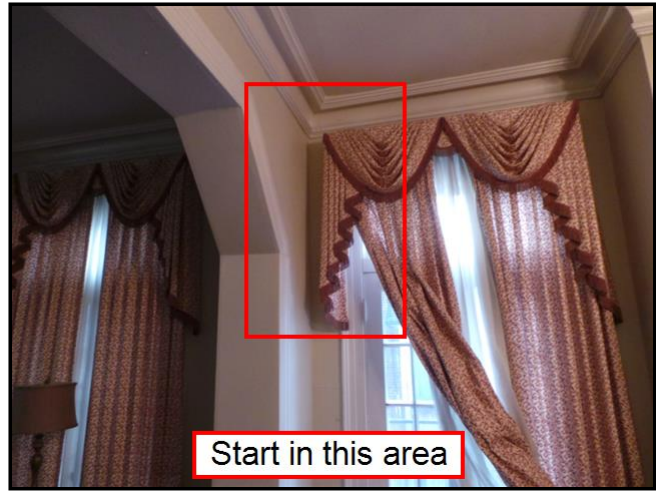
As mentioned above and based on the thermal images taken during the Inspection, I suspect warm water is leaking inside the wall cavity (left wall) on the left side of the tall window/door adjacent to the dining room. The hot riser pipe, which is located inside the wall cavity, is suspected to have ruptured. This has likely been caused by the extreme cold temperatures experienced in this area over the past several days. In older homes it's very common to have vertical riser pipes on an exterior wall. These pipes are subjected to extreme temperatures and should be properly insulated.

The pipe leak has potentially caused hundreds of gallons of water to leak inside the wall cavity, on the exterior wall, in the sub-flooring, and down into the ceiling, walls and floor of the finished basement. A **Qualified** Plumber should be retained to locate and fix the damaged pipe. I would suggest having the contractor start by cutting into the wall cavity in the dining room (See Pictures below). It is also recommended you retain the services of a **Qualified** Water Damage Restoration Contractor, which typically offers the following services:

Recommend **Corrective Action** by a **Qualified** Contractor.
