ITI Electrical-Mechanical Survey

Job Number: 20141229-Sample

Type of Inspection: Electrical (Qualitative)

Date of Inspection: December 29, 2014 at 8:30am to 1:45pm

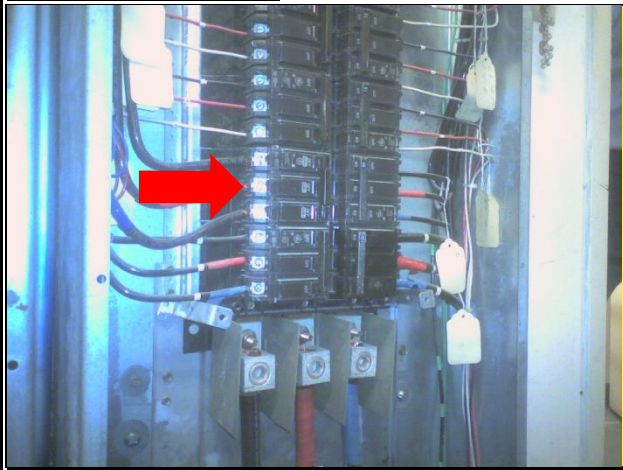
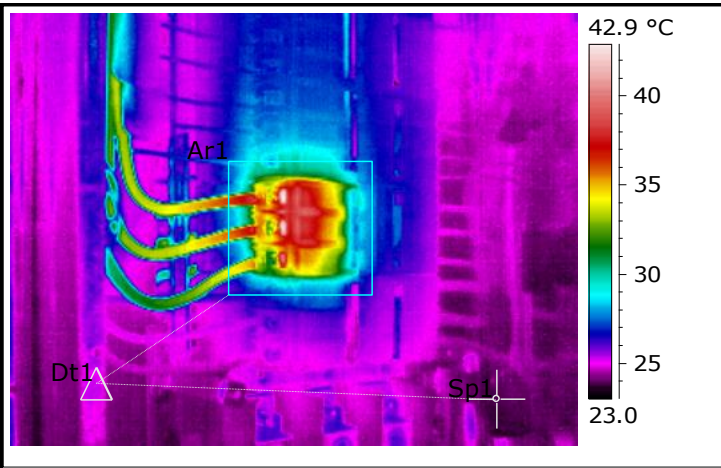
Image Date	12/29/2014
Image Time	8:43:16 AM
Image Camera Type	ThermaCAM T-400
Image Camera Lens	FOL10
Object Distance	3.0 feet
Location	Penthouse Mechanical Room
Equipment	Panel ME-PH (Condenser Pump P4)
Type	3 Phase Circuit Breaker
Nom load	100 amps
Actual load	#31=52 amps, #33=51 amps, #35=50 amps

Filename	IR_3435.jpg
Atmospheric Temperature	21.7 °C
Dt1 Value	19.0 °C
Emissivity	1.00
Ar1 Max. Temperature	42.9 °C
Sp1 Temperature	23.9 °C

Priority Rating 3

The load on this circuit was within acceptable parameters, but the temperature rise over ambient was elevated. Recommend monitoring and trending temperature rise over ambient. Corrective measures required as scheduling permits.

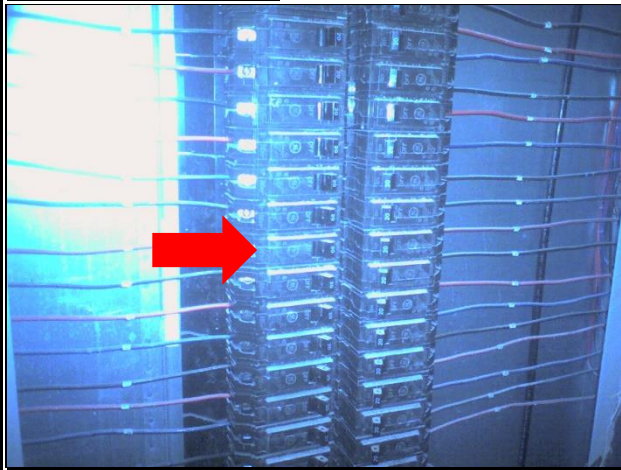
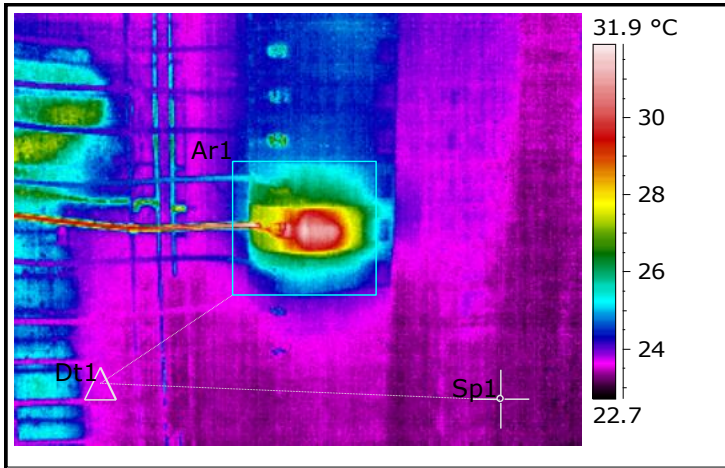
Image Date	12/29/2014
Image Time	11:53:51 AM
Image Camera Type	ThermaCAM T-400
Image Camera Lens	FOL10
Object Distance	3.0 feet
Location	4 th Floor Hallway
Equipment	Panel LR4
Type	Circuit Breaker #1
Nom load	20 amp
Actual load	1.2 amps

Filename	IR_3437.jpg
Atmospheric Temperature	21.7 °C
Dt1 Value	8.7 °C
Emissivity	1.00
Ar1 Max. Temperature	31.9 °C
Sp1 Temperature	23.3 °C

Priority Rating **4**

The load on this circuit was within acceptable parameters. Recommend monitoring and trending temperature rise over ambient. Consider replacing circuit breaker at the next scheduled maintenance interval.
